## PROPERTY INSPECTION REPORT

**Report #:** HCR20060312-01

**Concerning:** 123 Partial Report Ssample, San Antonio, TX 78247  
 (Address of Inspected Property)

**By:** Harold C Robertson, #905 03/12/2006  
 (Name and License Number of Inspector) (Date)

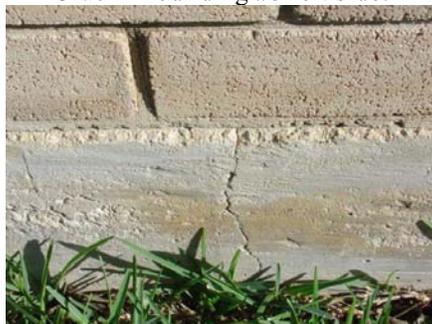
The cracking in the exterior grade beams should be monitored over time as repairs may become necessary.

Crack in building #3 left side.

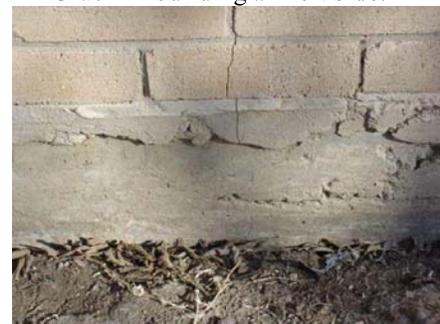
Crack in building #1 left side.

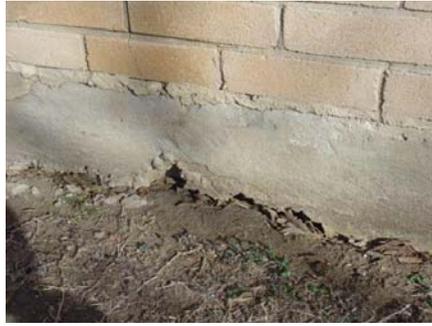
The concrete beam on the left side of building #1 has a visible void. This should be further investigated to determine the beam integrity.

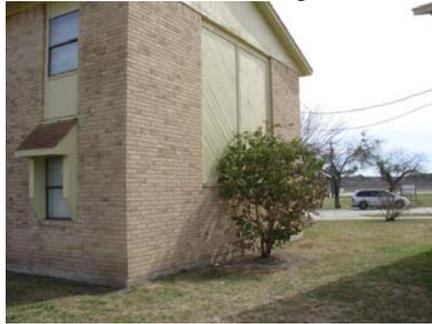
Tree(s) and/or foliage that are excessively close to the structure may have a tendency to disrupt drainage pipes, cause mechanical damage to the exterior of the structure, and influence the foundation over time.

Left side of building #2.

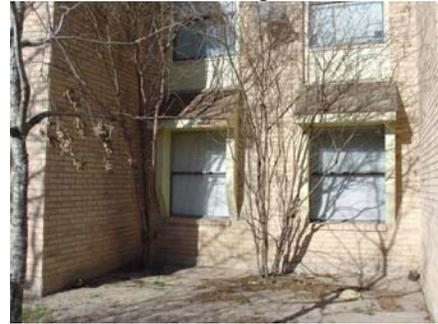
Front of building #3.

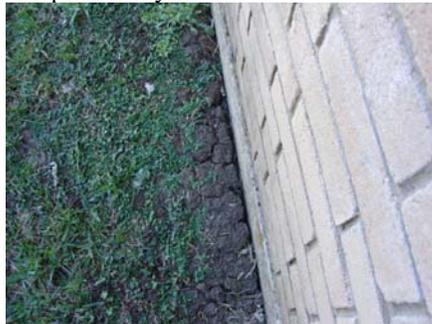
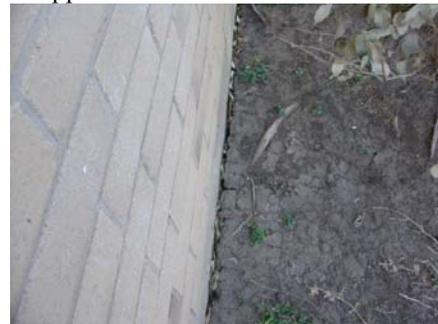
Roof runoff exists (poorly functioning or non-existent gutter system).

Dry soil conditions exist adjacent to the structures in most areas around all three buildings. The soil pulls away from the foundation and a lack of support results.

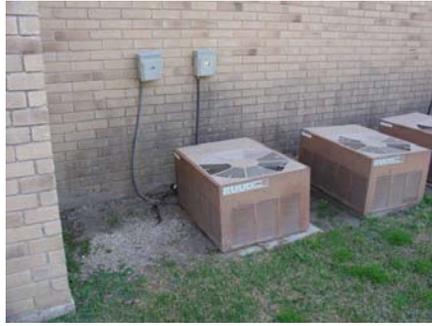
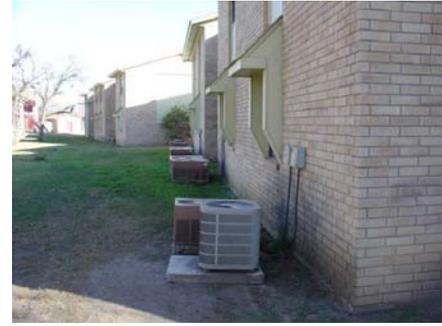
Soil erosion exists adjacent to the structure in several areas. There is not positive drainage away from the foundations in many areas as a result.

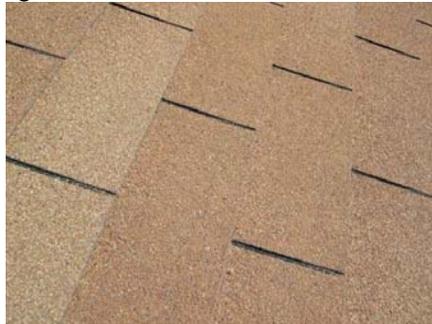
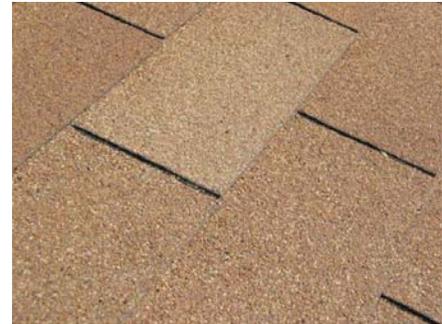
The shingle surfaces have some granule loss although they are in fair condition overall for their age.

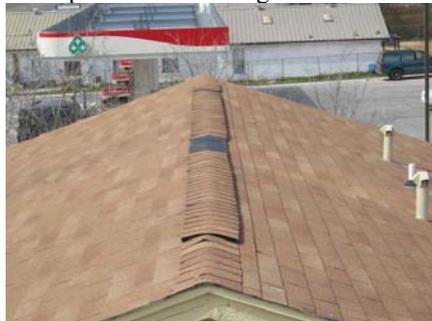
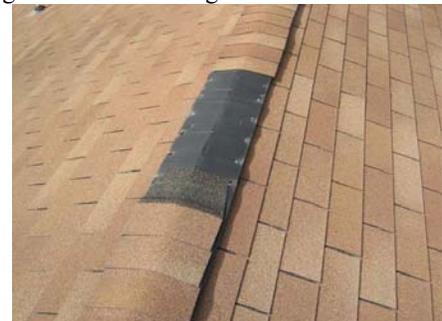
Shingles are torn or have blown off of the roof surfaces at all three of the buildings. It is recommended that these items be repaired immediately. There are roughly half a dozen to a dozen damaged shingles on each building.

Examples of this damage are evident at the ridge vents at buildings 1 and 2.

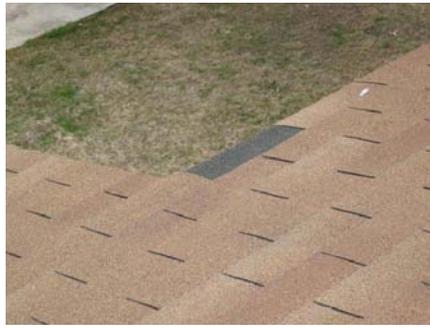
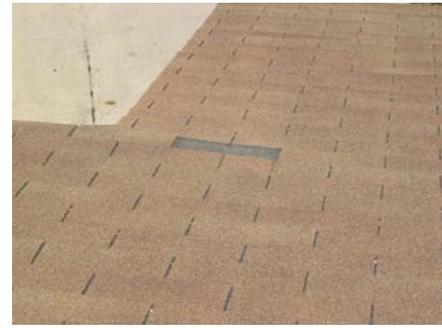
Examples are also visible at many of the roof edges, especially at buildings 1 and 2.

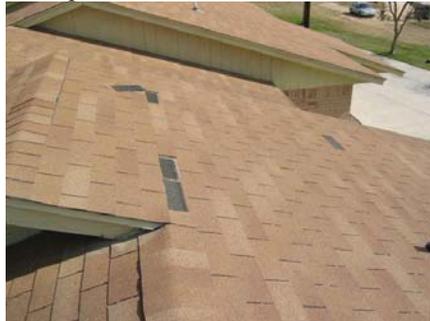
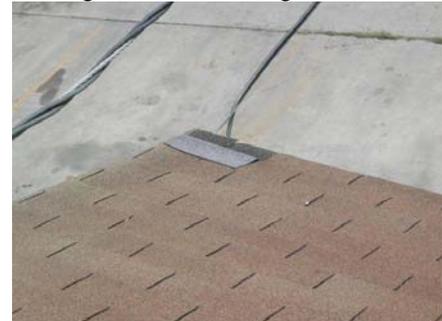
Examples are visible at the middle sections and far right end of building 2.

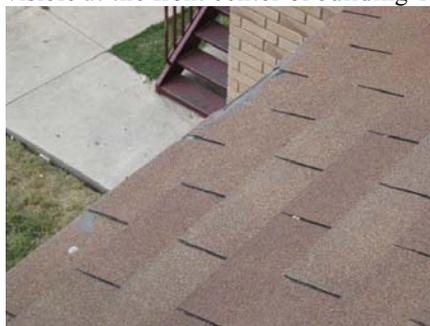
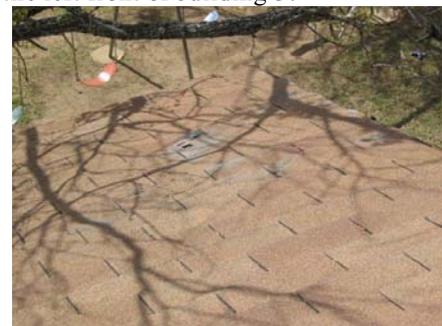
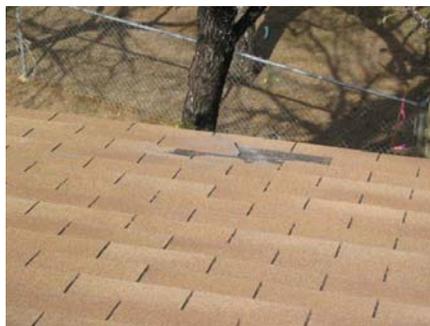
Some shingles are scuffed/damaged, apparently from previous branch contact. Examples are visible at the front center of building 1 and at the left front of building 3.
