Professional Inspection Report

**123 Your New Home
San Antonio, TX 78247**

**Sample A Report
03/12/2006**

PROPERTY INSPECTION REPORT

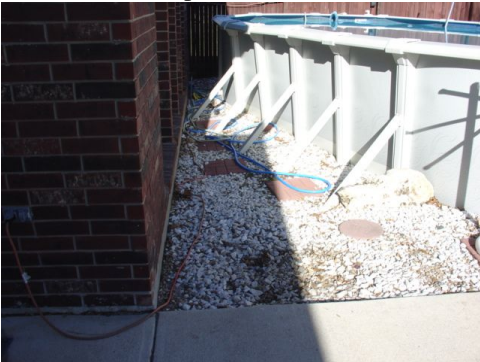
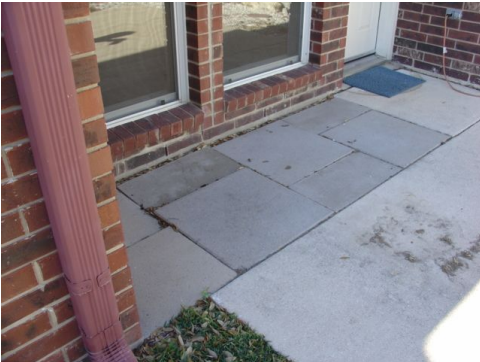
There is not positive drainage away from the foundation at the rear primarily at the rear center and rear between the pool and home.

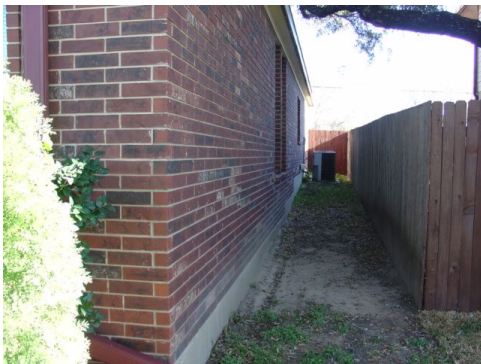
Roof runoff exists (poorly functioning or non-existent gutter system). The right side of the home does not have a gutter system.

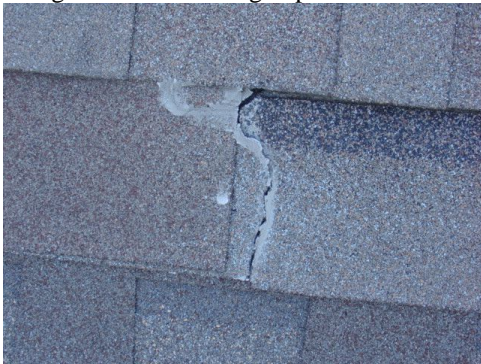
Shingles are torn/damaged/perforated and/or missing in one or more areas.

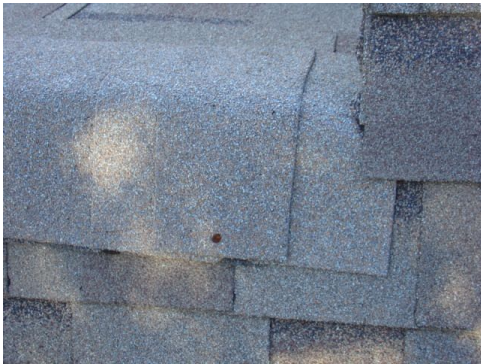
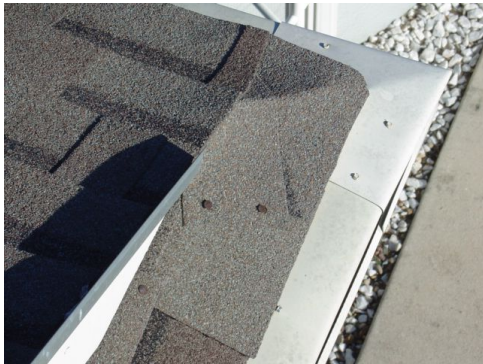
Exposed and improperly sealed nail and/or staple heads are visible through the shingle surfaces and/or flashing areas.

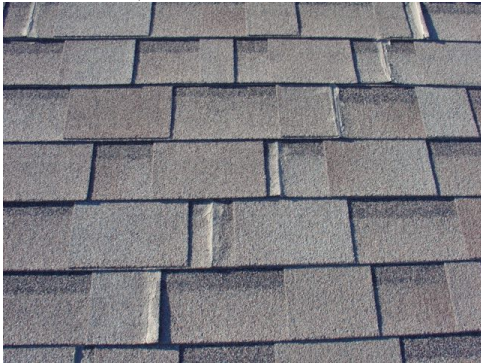
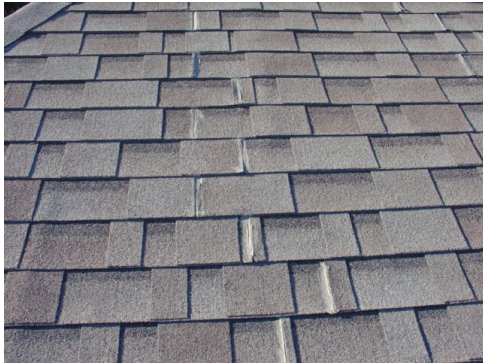
There are area of the roof or roof components that have been patched with an excessive amount of sealing tar. (patches of this type are temporary in nature and generally require ongoing maintenance).

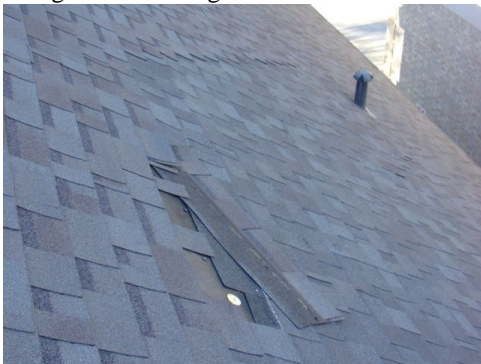
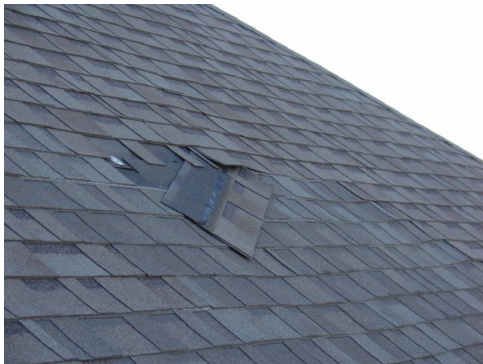
Shingles are coming loose on the left side of the home.

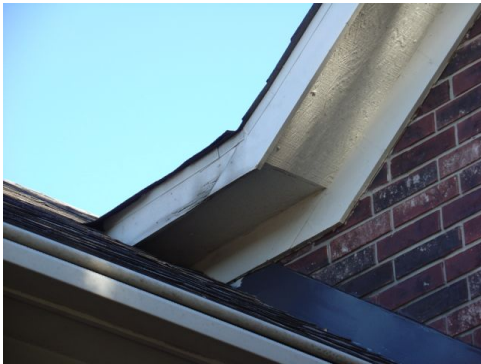
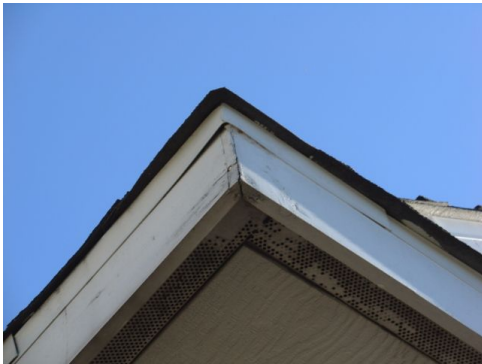
Exterior Walls/Siding:
Fascia boards are water damaged, rotted and/or have visible evidence of wood filler or repairs.
Most notable was at the front center and left front corner.

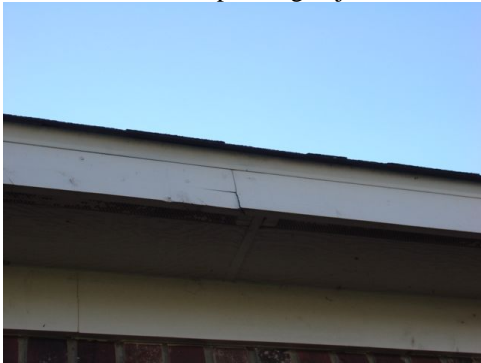
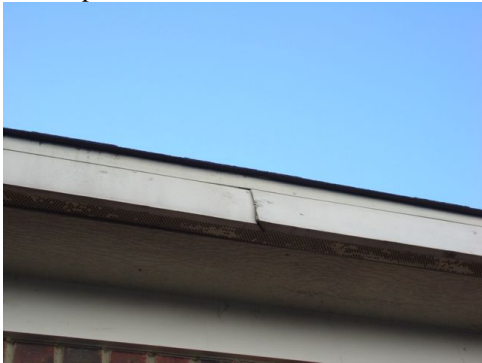
Fascia boards are separating at joints and/or are twisted/warped.

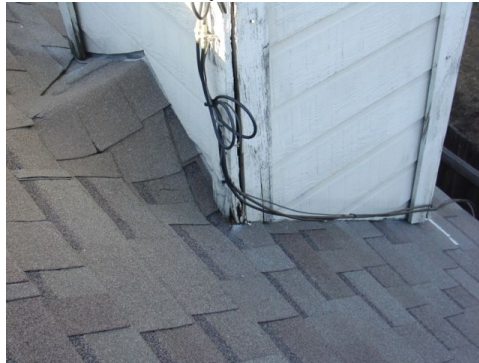
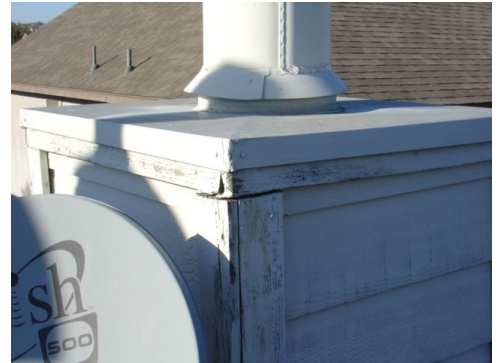
Trim boards are water damaged, rotted and/or have visible evidence of wood filler or repairs. The trim on the chimney was most notable.

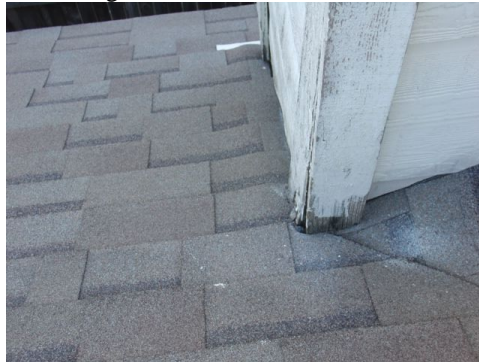
The siding and/or trim is in direct contact with the roofing material(s) at the chimney.

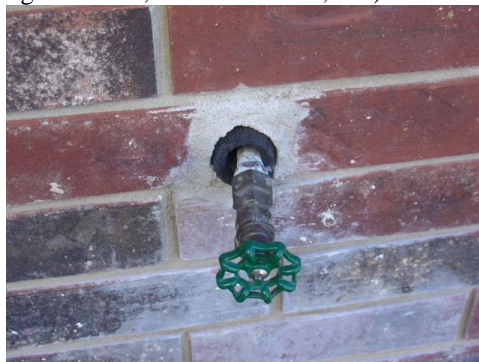
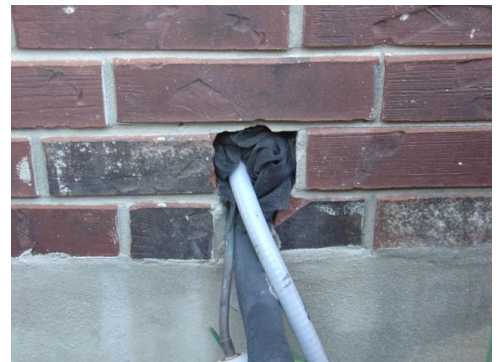
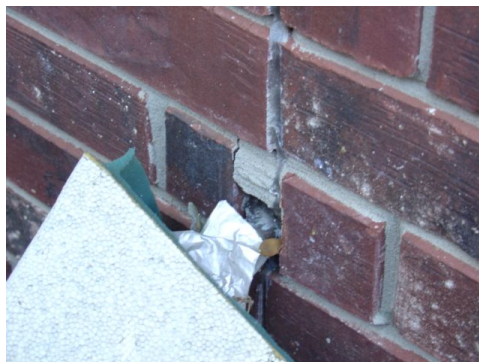
Poor seal noted at various exterior wall penetration points (i.e. Freon line entry point, exterior light fixtures, exterior faucets, etc.).

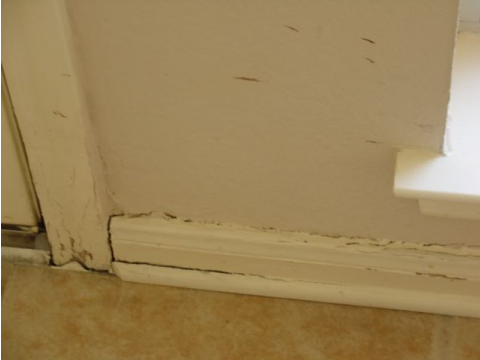
Interior Walls:
The baseboard(s) is water damaged in the rear adjacent to the rear doorway.

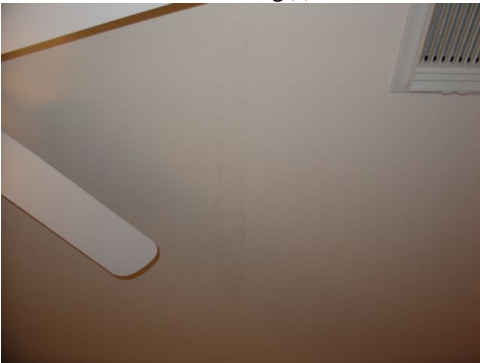
Comments:
Interior Ceilings:
Water stains on the ceiling(s) in the left side bedroom.

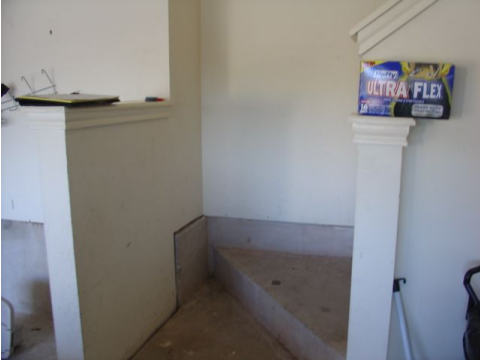
Interior Steps/Stairways/Railings:
The handrail is missing at the garage steps.

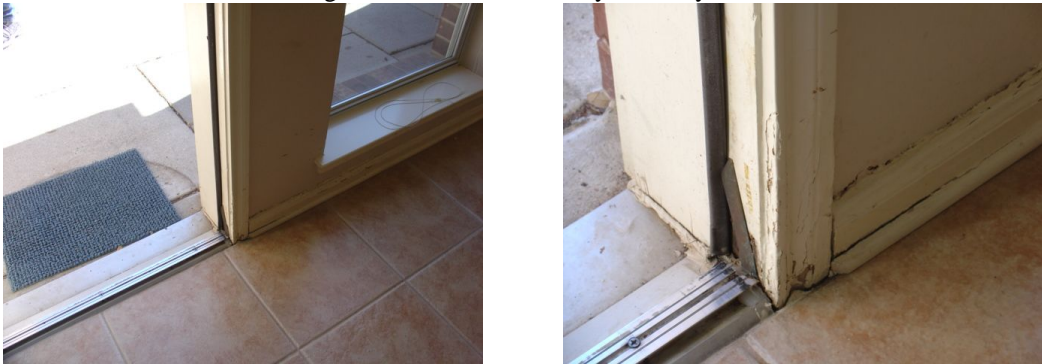
Comments:
Interior/Exterior Doors:
The door frame is water damaged/rotted at the rear entry doorway.

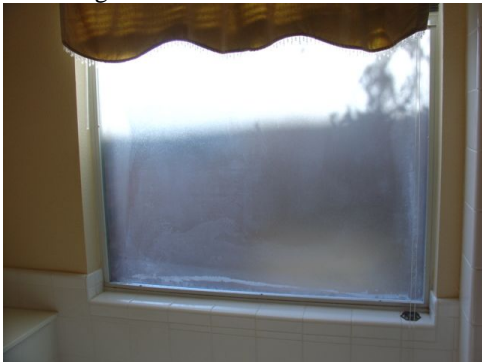
The thermal pane windows have defective seals. Moisture is visible between the glass and/or is becoming clouded at the master bathroom.

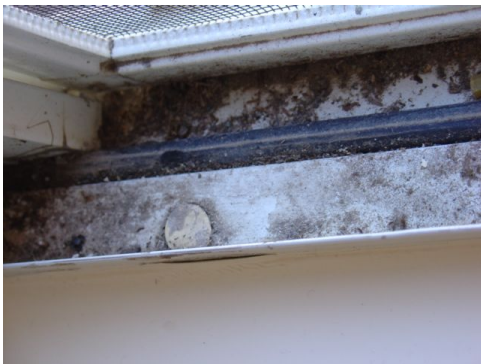
Poor caulking seal at the window alarm contact sensors. This is conducive to moisture penetration into the wall(s) under the window(s).

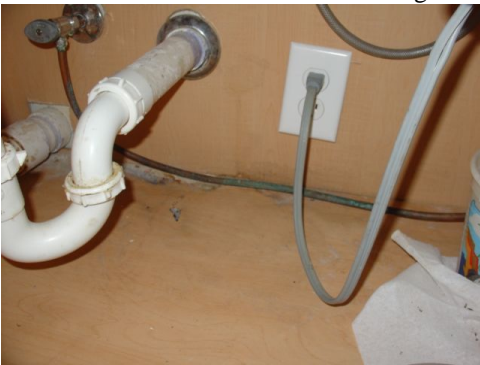
The shelf under the sink is water damaged in the kitchen.

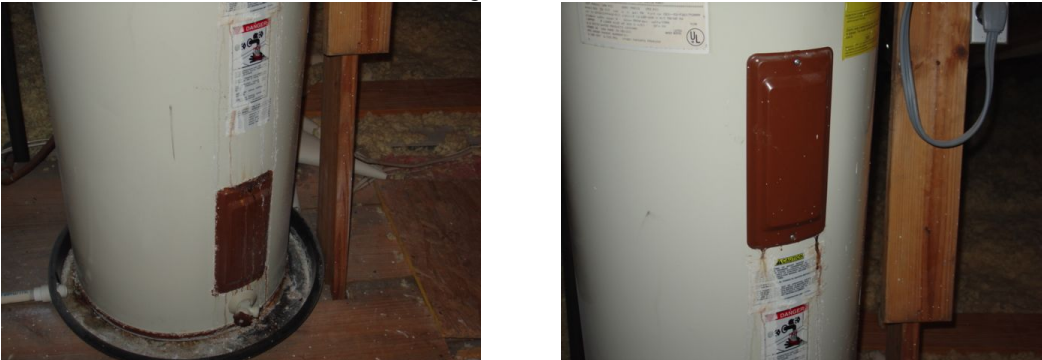
Water Heater:
The water heater tank is rusted and/or damaged.

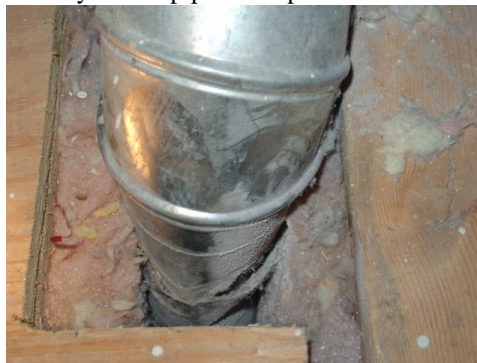
The dryer vent pipe has separated and leaking into the attic.

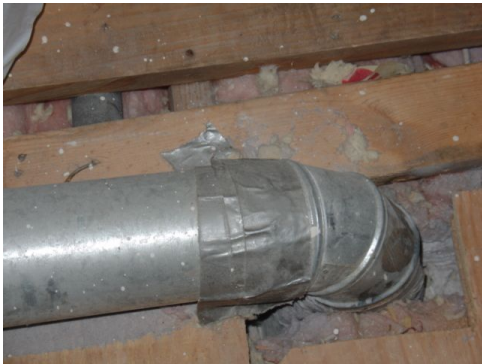
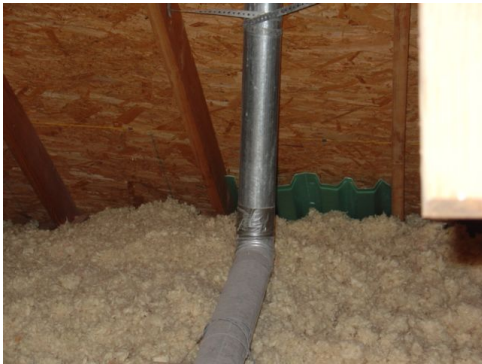
The dryer vent pipe is excessive in length and may not operate properly as a result or will need cleaning on a regular basis.

The dryer vent pipe has duct tape on it.
