# PROPERTY INSPECTION REPORT

**Report #:** DTA20060210-01

**By:** Dean T Abel, #3644 02/10/2006  
 (Name and License Number of Inspector) (Date)

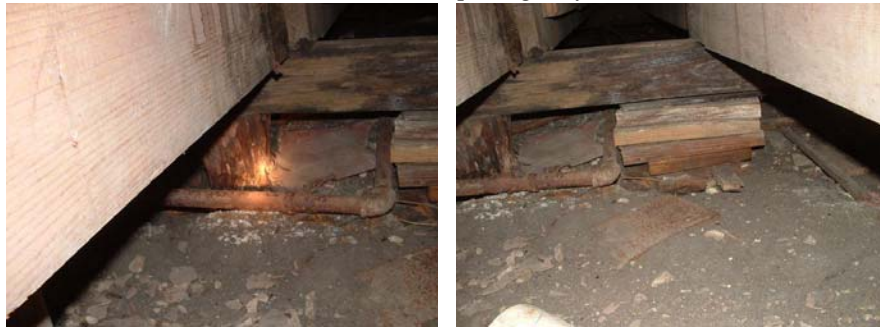
The floor section behind the bar area is constructed of a pier and beam style foundation that is apparently quite old or original. The cedar posts used as foundation support in this area are severely pencil-pointed and water damaged at bottom. It is apparent that some unprofessional repairs were

made at some point in the past with stacked two by fours. This is entirely inadequate for structural bracing. Note also that the crawl space access was quite limited (with very low clearances). This area was viewed from at/near the floor access opening only.

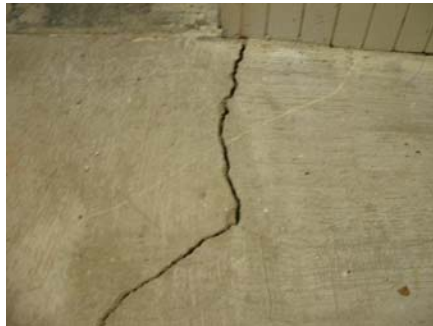
The left rear concrete slab section is severely cracked and broken. The amount and severity of cracking here is evidence of poor or inadequate steel reinforcement or shallow beams. This slab section should be considered to be in a state of "failure".

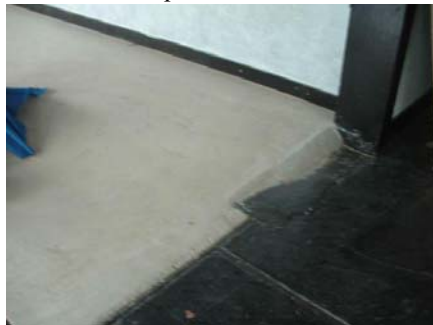
Noted a newer section of concrete flooring that was poured at the left front room of the building. The reason for this pour was undetermined.

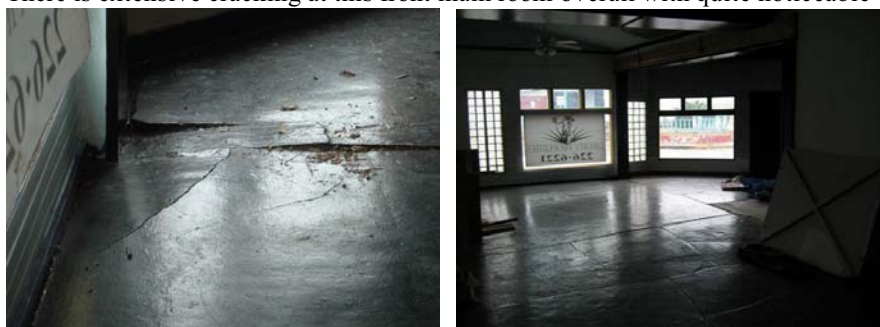
The perimeter beam is noticeably dropped and cracked at the left front corner of the front main room. There is extensive cracking at this front main room overall with quite noticeable unevenness.

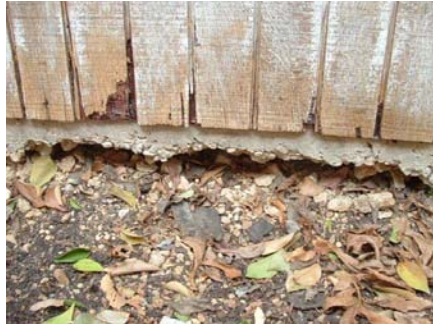
The slab addition at the rear of the building does not visibly have a proper foundation grade beam. The bottom of the concrete is visible and soil erosion is occurring here exposing the foundation underside.

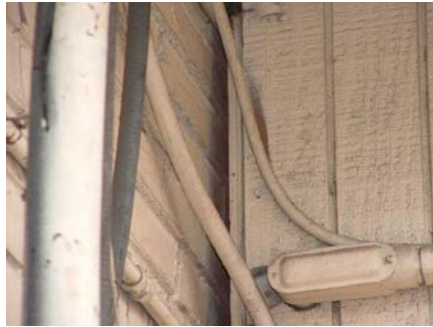
The rear addition is visibly separating from the main structure.

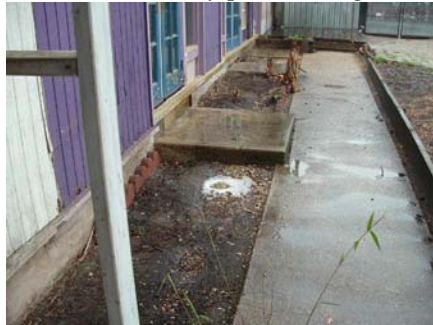
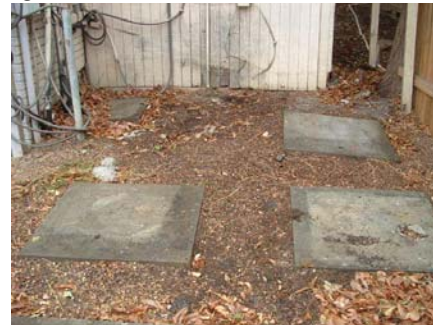
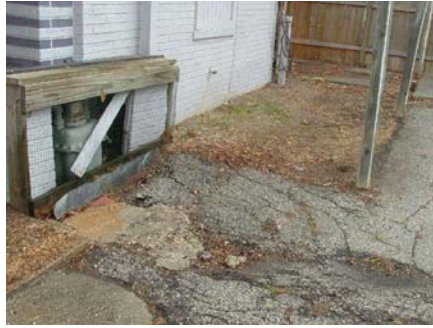
There is not positive drainage away from the foundation edge in place around many areas of the foundation. In particular, drainage along the left side of the building is trapped against the structure. There is also visibly poor drainage at the right side of the structure.

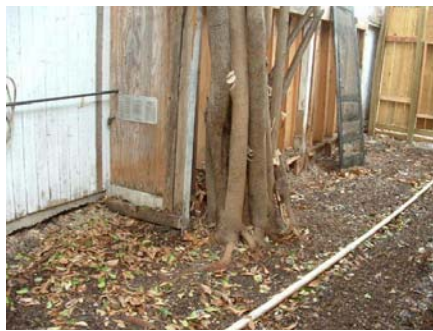
Tree(s) and/or foliage that are excessively close to the structure may have a tendency to disrupt drainage pipes, cause mechanical damage to the exterior of the structure, and influence the foundation over time.

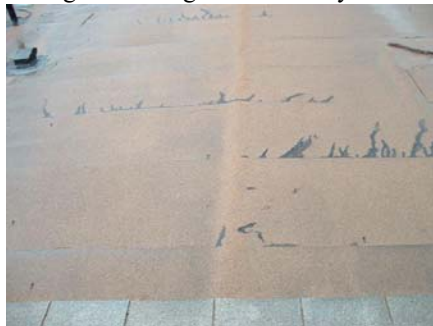
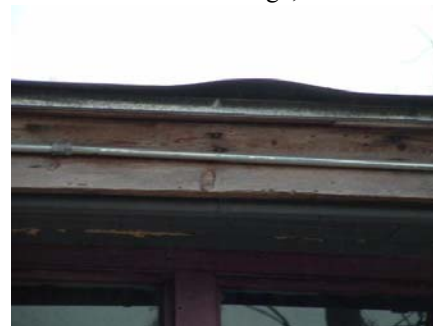
Sections of the rolled roofing are excessively buckled. This can lead to accelerated deterioration and leakage. Roofing is also visibly lifted at some areas at the roof edge, such as at the left side.

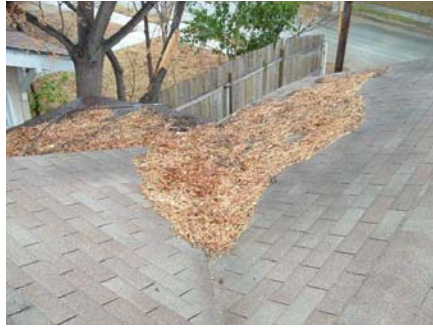
There is an extensive amount of debris on the roof in areas.

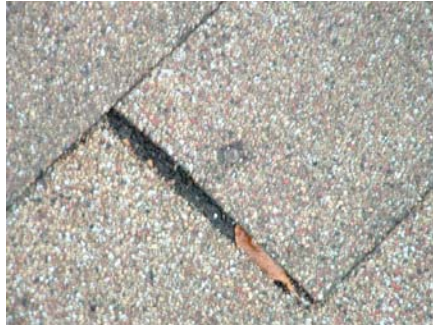
Exposed nail and/or staple heads are visible through the roof shingle surfaces. These are potential roof leakage points (i.e. nails have backed up thru the shingles or are otherwise exposed).

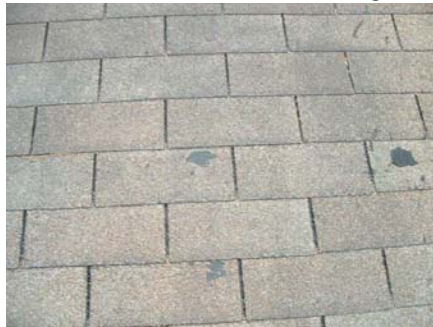
There are areas of considerable degranulation of the roofing materials. Life is very limited.

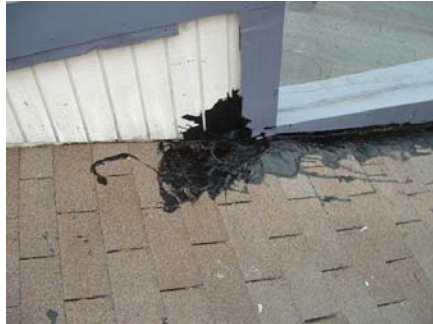
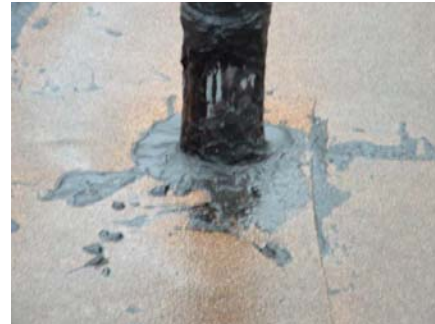
There are several areas visible where repairs have been made to the roof surfaces with a considerable amount of sealing tar. It could not be determined how effectively these repairs were made.

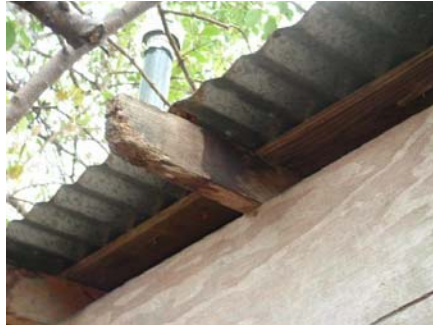
At the left rear addition, the roof coverings do not cover the rafter ends. These rafters are water damaged in many areas.

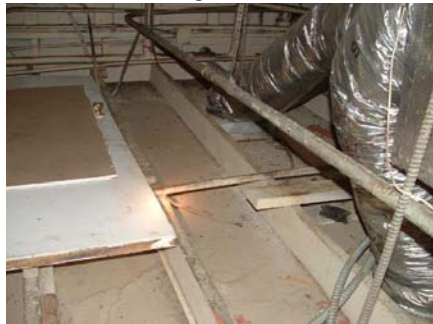
There is no ceiling insulation visible at the rear portion of the building.

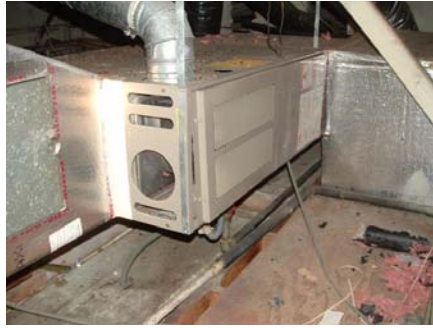
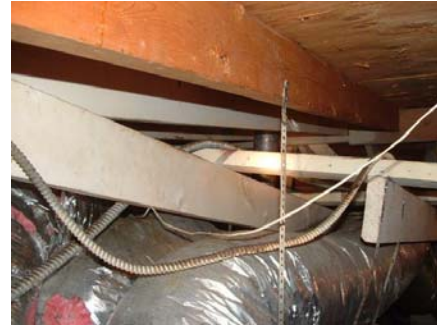
Collar ties and rafters are visibly deflecting toward the rear end of the attic. The rear gas heater is being improperly supported by roof collar ties in this area.

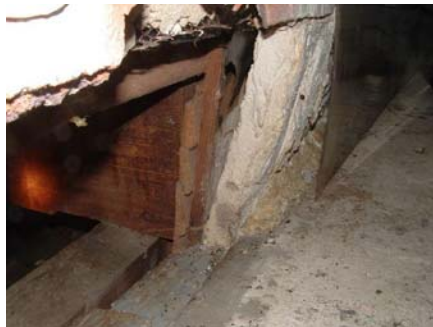
It is clear that the original structure has had multiple sidings/veneers placed on it over the years. This can be seen at the store room, where the original siding was wood, with plaster/stucco placed over the wood, and another veneer placed on top of the stucco. Multiple layers (such as exist here) can conceal underlying damage. There are many surfaces that could not be adequately viewed to determine their condition.

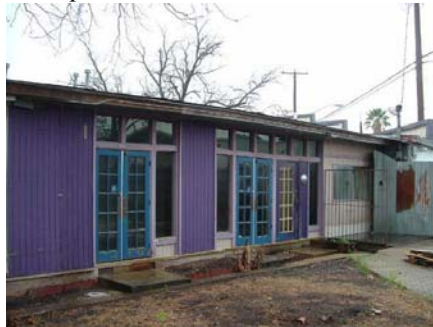
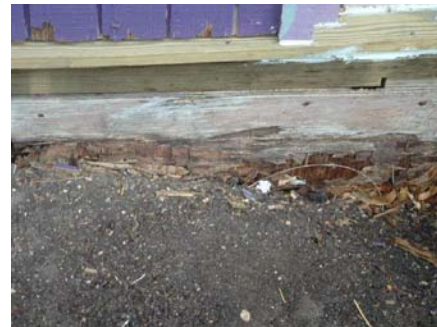
The exterior walls/siding exhibit very poor protection against the elements at various siding and trim junctures and at exterior wall penetration points, and there are many areas where wood surfaces are exposed to damage. A thorough reevaluation of the exterior siding's ability to shed water and prevent water penetration is recommended. Also, see further below.
