Professional Inspection Report

**123 Your New Home
San Antonio, TX 78247**

**Sample A Report
03/12/2006**

PROPERTY INSPECTION REPORT

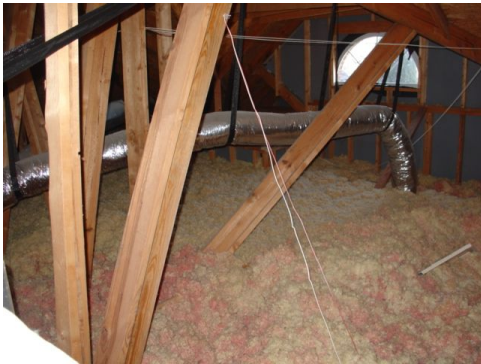
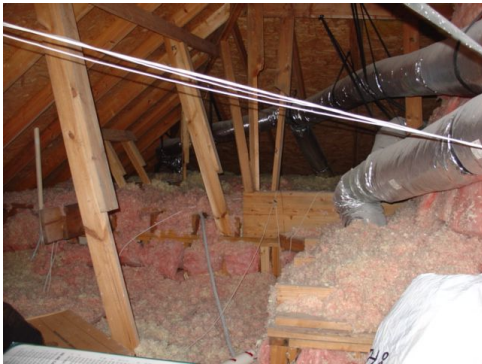
Attic:
Photos provided as a courtesy.

Ceiling Insulation:
Insulation Type(s): Blown in insulation **Approximate Depth:** greater than 10 inches

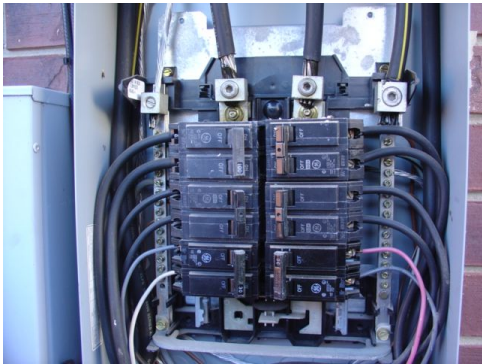
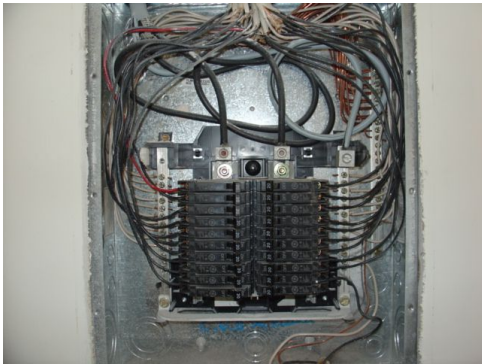
II. Electrical Systems
A. Service Entrance and Panels
Comments:
Service Entrance & Panels:
Visible Wiring Type(s) (Service): Copper
Visible Wiring Type(s) (Feeders): Copper
Note: The wiring types listed above are for identification purposes only and are not in need of repair.
Photos provided as a courtesy.

Main Disconnect:
Main Panel(s) labeled: Yes (Accuracy of labeling not determined)
